JPL Contract 951709

# STERILIZABLE LIQUID PROPULSION SYSTEM

## Ninth Quarterly Progress Report

April 1969

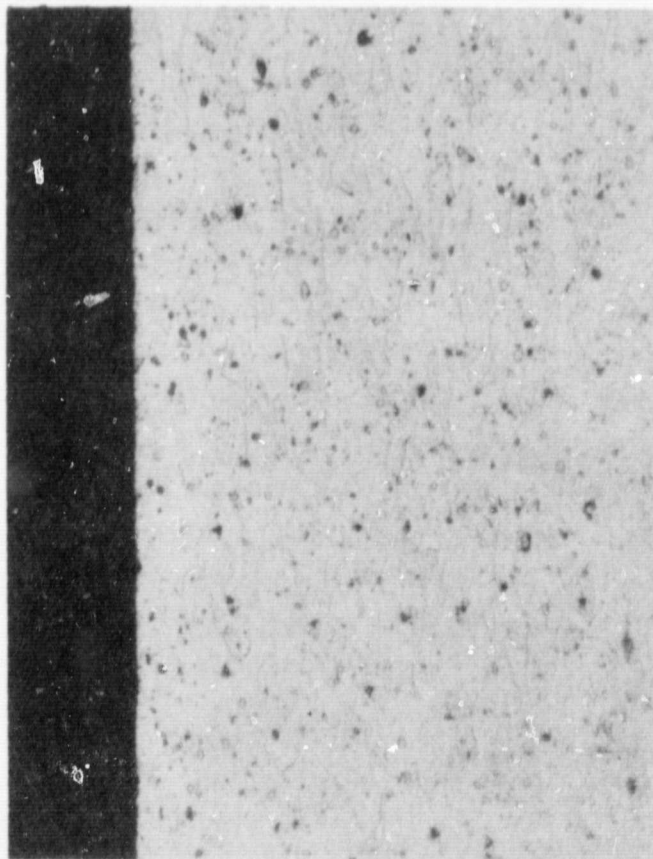
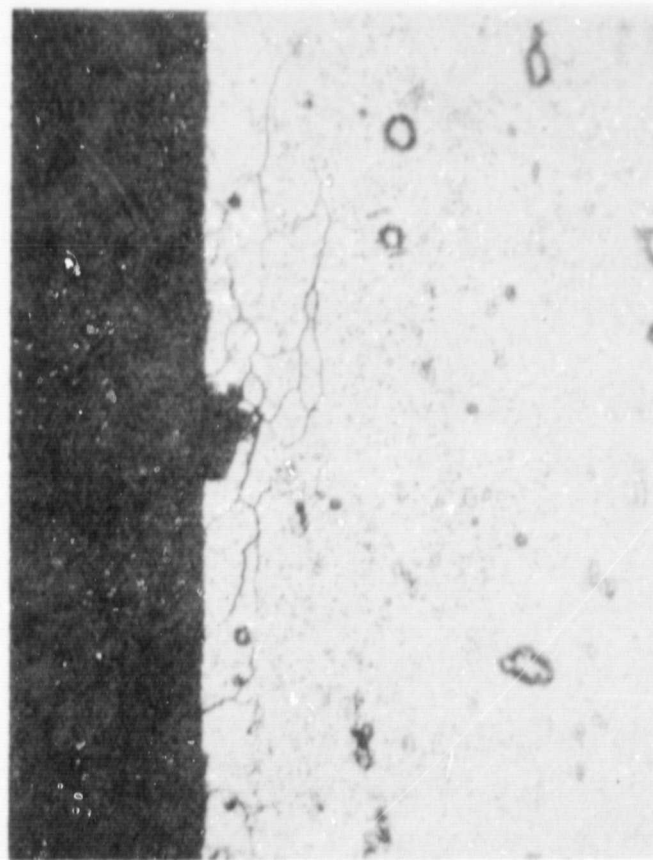
No observable attack. Anodic coating was intact, as determined by electrical measurements which showed that the surface of the specimen was not conductive. Figure 1 shows a photomicrograph which is representative of the degree of protection afforded aluminum by the anodic coating produced by chromic acid.

No attack is noted on the chromic acid anodized aluminum

Fig. 1: Aluminum (2014-T6) After Exposure to  $\text{N}_2\text{O}_4$  for 600 Hours at 275°F (200x)

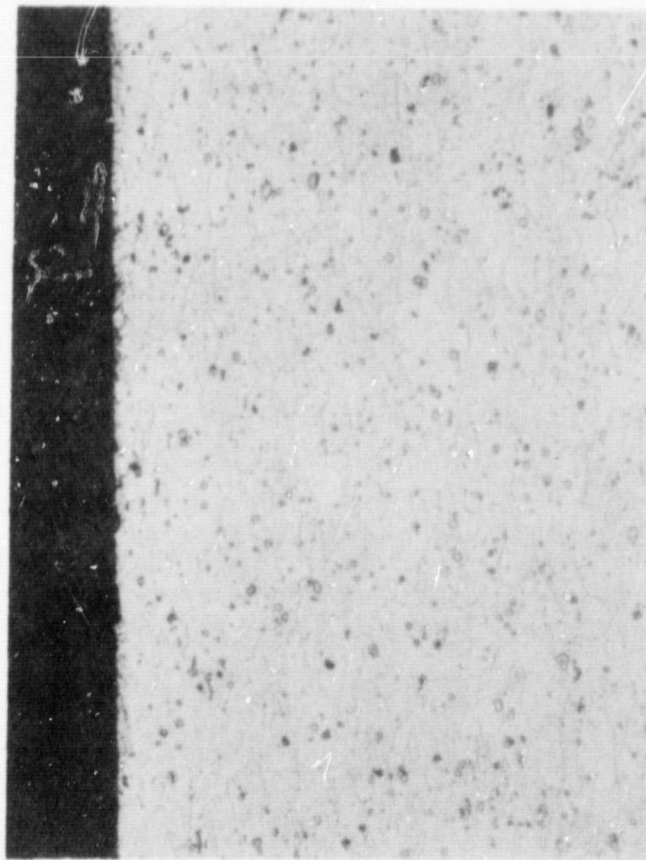
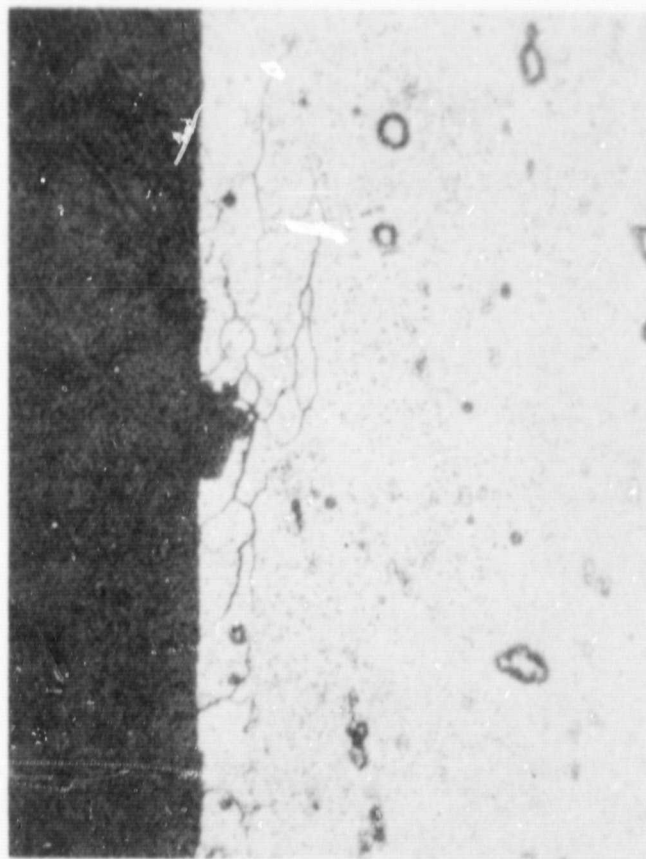
No observable attack. Anodic coating was intact as determined by electrical testing. See Figure 2 for the photomicrograph which demonstrates the protection afforded.

No attack is noted on the Sulfuric Acid Anodized Aluminum

Fig. 2: Aluminum (2014-T6) after Exposure to  $N_2O_4$  for 600 Hours at 275°F (200x)

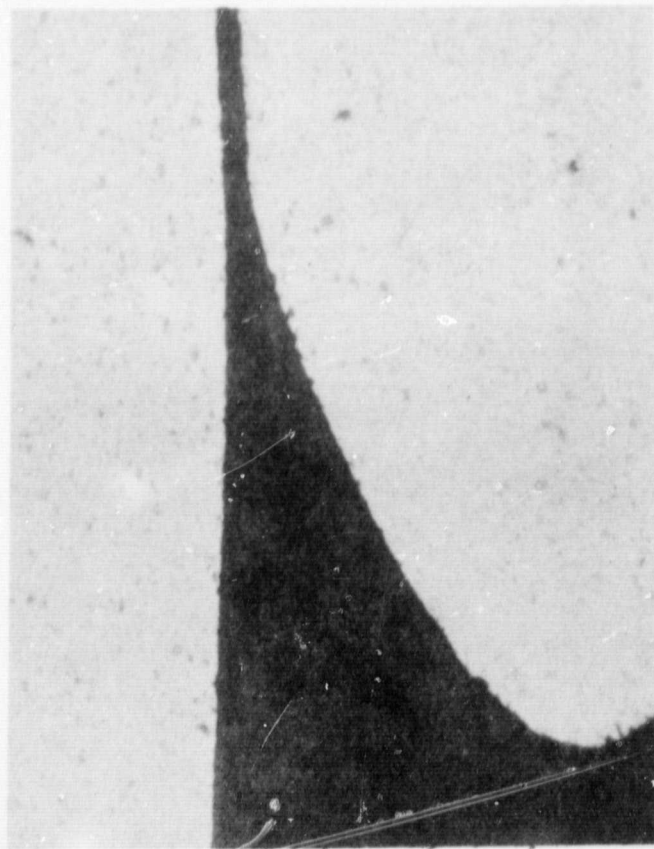
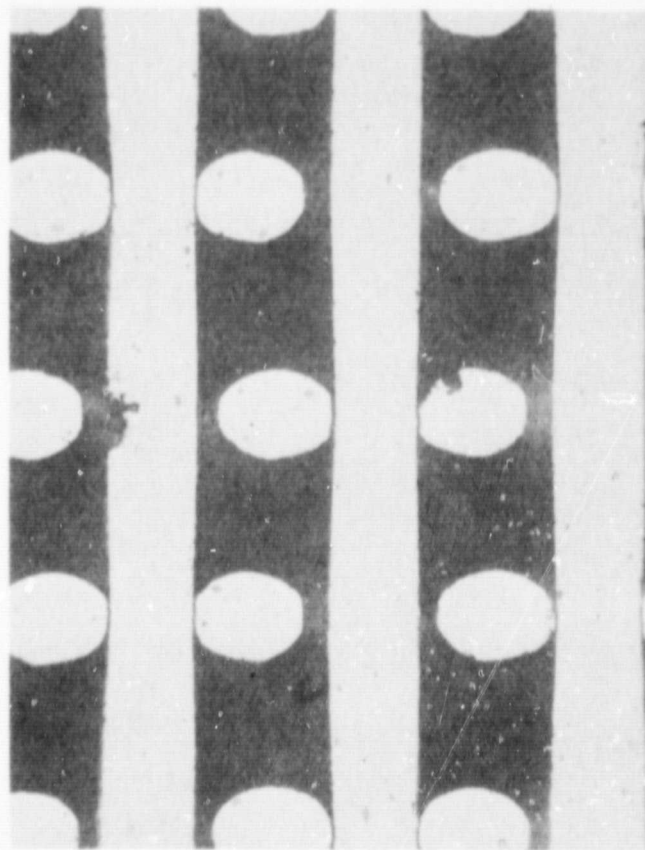
The Chromic Acid Anodized Specimen Sustained No Attack

Fig. 3: Aluminum Screen After Exposure to  $\text{NO}_2$  for 600 Hours at  $275^\circ\text{F}$  (200x)

No observable attack was found. Anodic coating was intact.

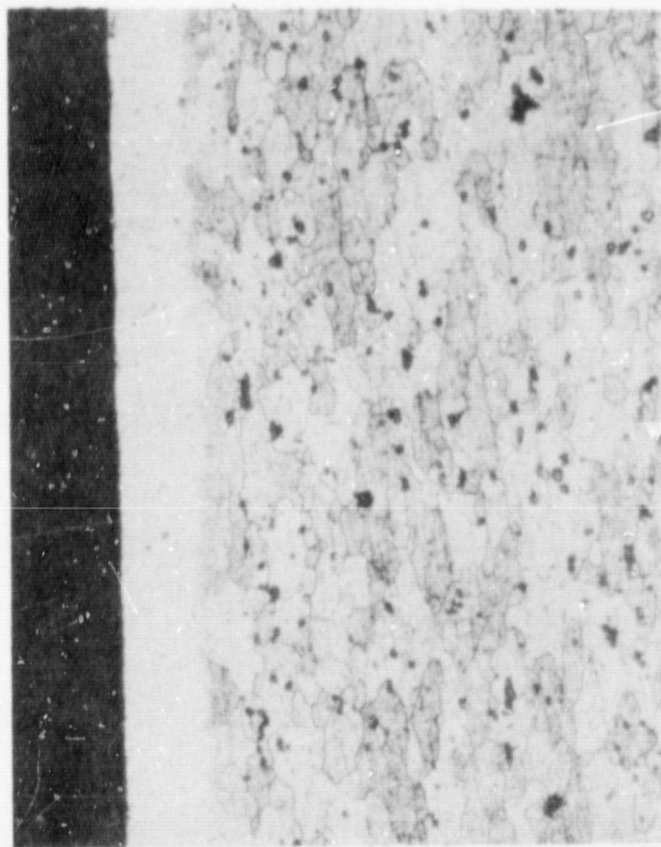
Surface is free of pits - there was no penetration of the clad coating

Fig. 4: Aluminum (2024-T3) Clad with Pure Aluminum After Exposure to  $\text{N}_2\text{O}_4$  for 600 Hours at  $275^\circ\text{F}$  (200x)

Degree of attack was not significant. A minute amount of an externally fine powder was resident on the specimen surface. Figure 4 demonstrates the low degree of attack and the lack of any penetration of the cladding.

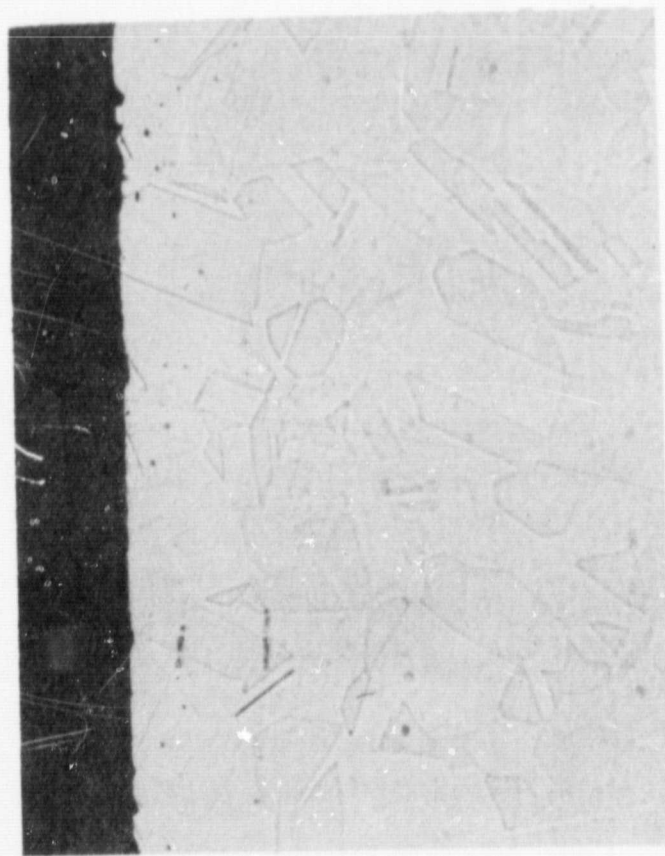
Fig. 5: 430 Stainless Steel Passivated Surface

This alloy sustained a minor degree of attack which resulted in superficial darkening of the specimen surface. There was no formation of any of the viscous corrosion product or of intergranular corrosion which was typical of the 300 series alloys. The surface darkening was primarily found in areas which were freshly sheared or had recently been shot peened. Since the specimen had been passivated prior to specimen preparation, and not after, this indicates that the specimen was more active in the freshly worked areas. Photomicrographs shown in Figures 5 and 6 were taken from a passivated surface (5) and a shot peened surface (6). As may be seen, no observable chemical attack existed on either area. The rougher appearance of Figure 6 is the result of the shot peening. This alloy may, for all practical purposes, be considered inert to the propellant sterilization environment.

There was no evidence of intergranular attack or pitting in either Fig. 5 or 6. Surface roughness shown in Fig. 6 was the result of shot peening.

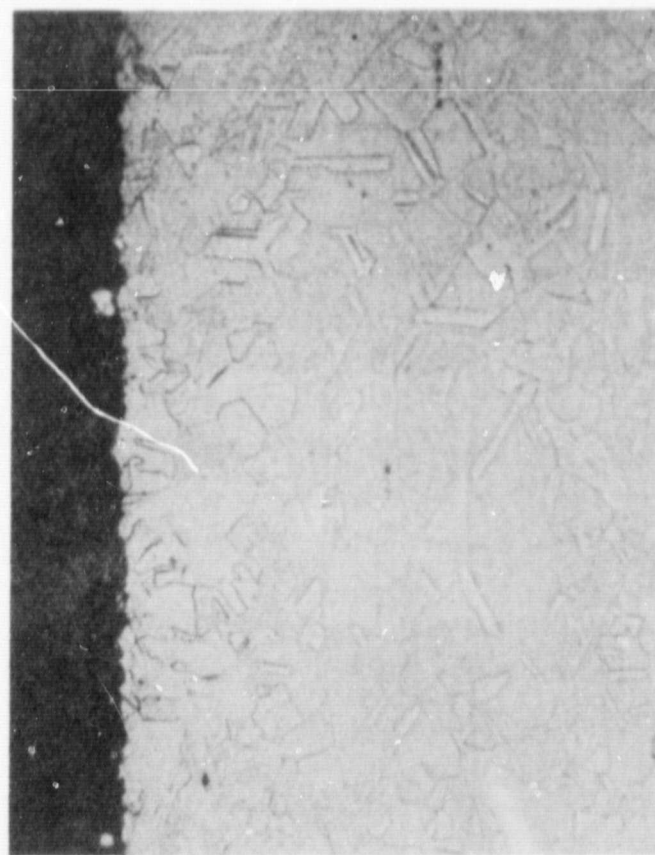
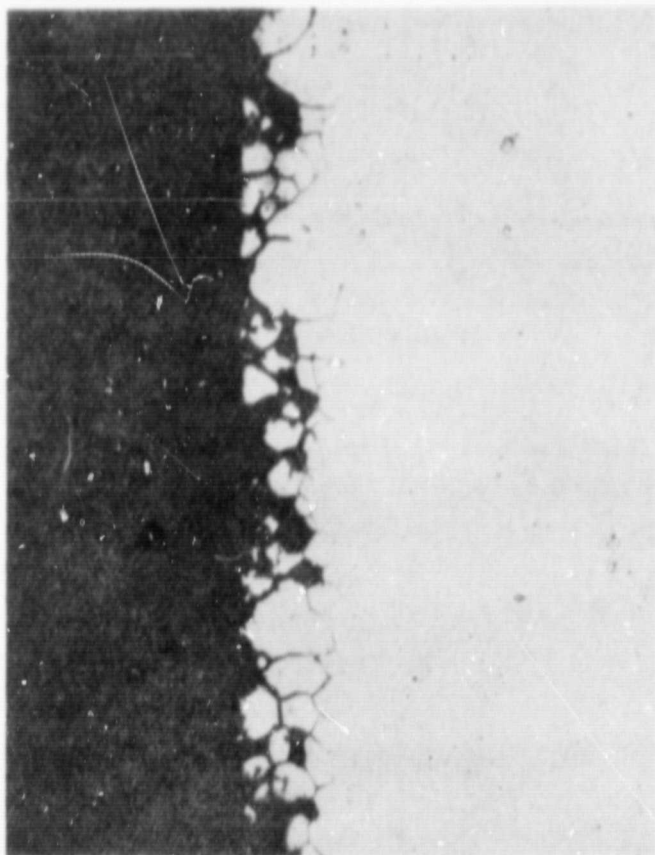
A light attack was sustained with resultant formation of a minute amount of a viscous corrosion product. The amount of the product formed was less than 1% of that formed when bare 321 stainless steel was exposed to  $N_2O_4$  during the sterilization cycle. Ordinarily, chromium plating is a poor protective coating against corrosion because of microscopic porosity inherent to this coating. This porosity apparently allowed the small degree of attack to take place. There are proprietary processes available which produce a crack-free chromium plating. Application of this type of coating could be of significant value in protecting the 300 series stainless steel alloys. Figure 7 illustrates the degree of protection provided by the standard plating process.

The chrome plated specimen was not attacked.

The plating is shown as a dark surface in Fig. a.

Fig. 7: Stainless Steel (321 series) after Exposure to  $N_2O_4$  for 600 Hours at  $275^{\circ}F$  (200x)

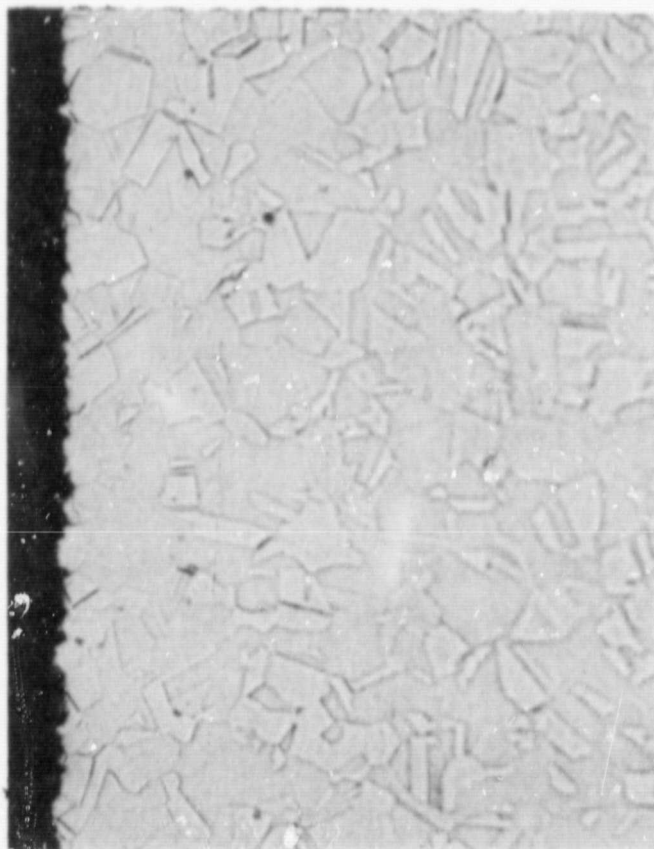
Surface attack was noted with resultant formation of a few beads of the viscous corrosion product and a general roughening of the specimen surface. This material was affected much less than were the bare 300 series alloys. Figure 8 illustrates the degree of attack.

Surface attack is evidenced by small pits. No significant intergranular attack is apparent

Fig. 8: Stainless Steel (AMS 5538) after Exposure to  $N_2O_4$  for 600 Hours at 275°F (200x)

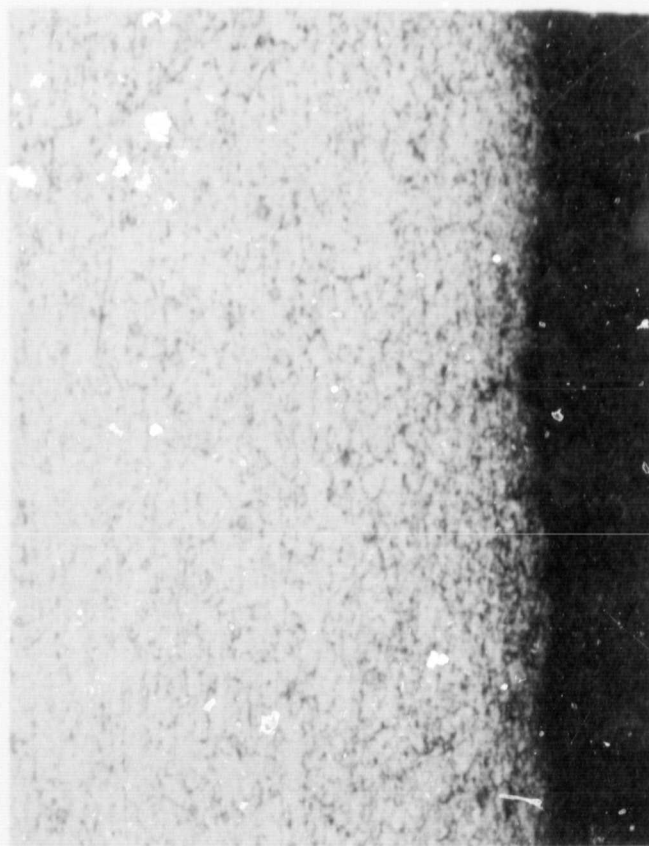
Surface attack was sustained with formation of a few beads of the typical corrosion product. This material reacted in a manner similar to that of AMS 5538. Figure 9 illustrates the minor degree of attack as well of the lack of significant intergranular corrosion.

Surface is roughened by pitting.  
Some intergranular corrosion is observable  
Structural strength not affected

Fig. 9: Stainless Steel (21-6-9) after Exposure to  $N_2O_4$  for 600 Hours at  $275^{\circ}F$  (200x)

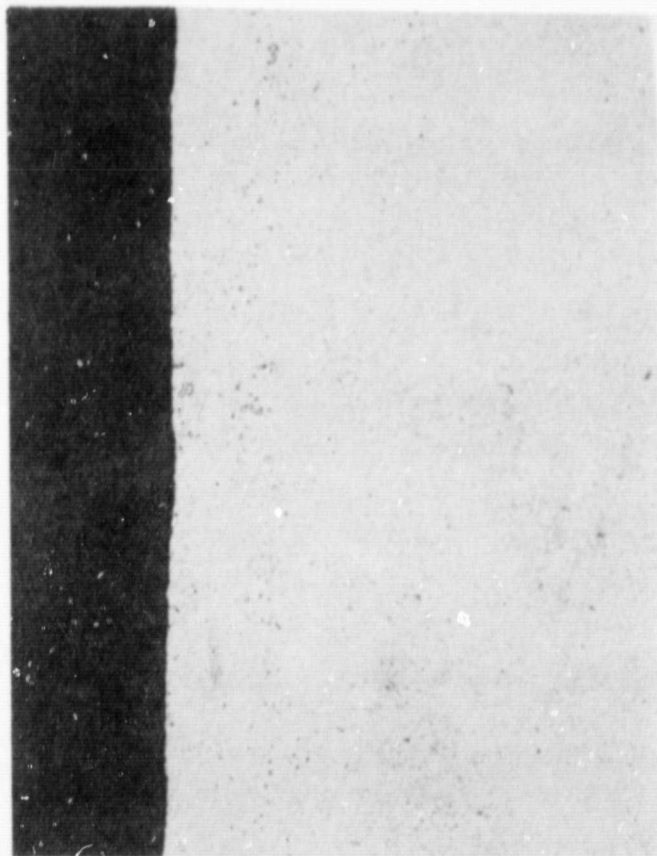
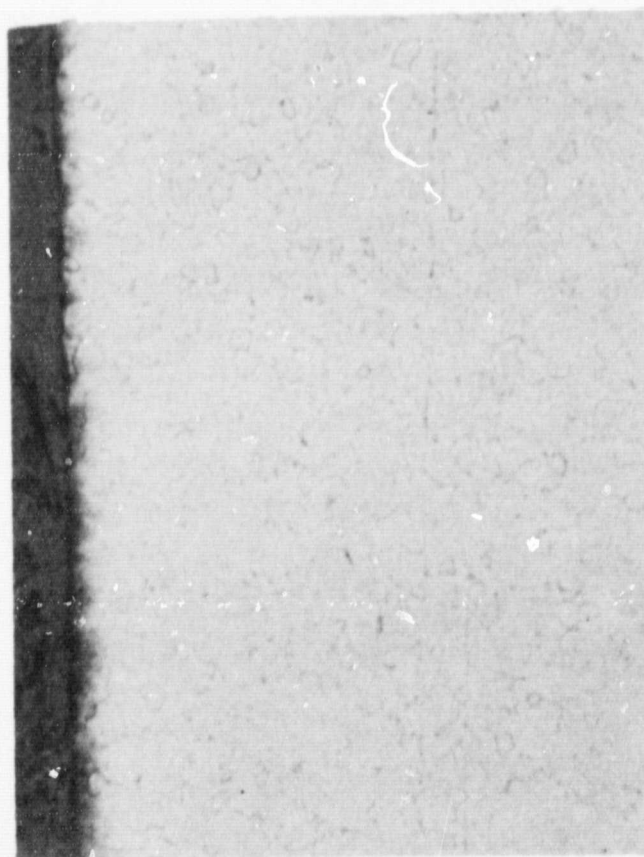
Light surface attack was found with the formation of an iridescent film which is typical of that formed on 6Al-4V titanium. Both alloys are considered comparable in resistance to attack by the propellant. Figure 10 demonstrates this alloys high degree of compatibility.

No evidence of attack of either alloy

Fig. 10: Titanium Alloys after Exposure to  $N_2O_4$  after 600 Hours at 275°F (200x)

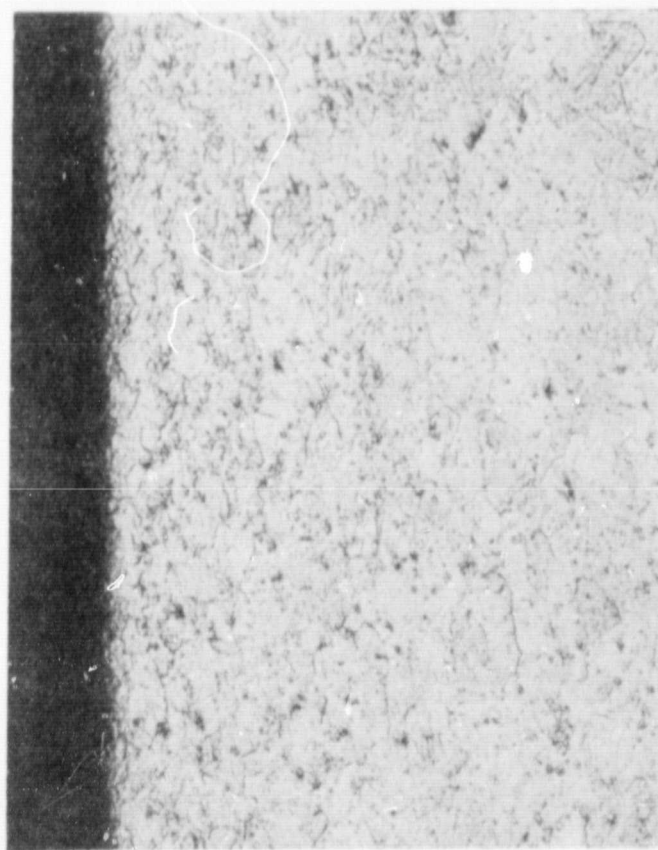
Light surface attack with attendant discoloration was noted. No loose corrosion products were formed. Figure 11 illustrated the degree of corrosion resistance that this alloy possesses.

No evidence of surface attack or intergranular corrosion observable.

The light attacked seen during surface examination was too small to be seen at 200x magnification.

Fig. 11: Columbium (DP-14) after Exposure to  $N_2O_4$  for 600 Hours at 275°F (200x)

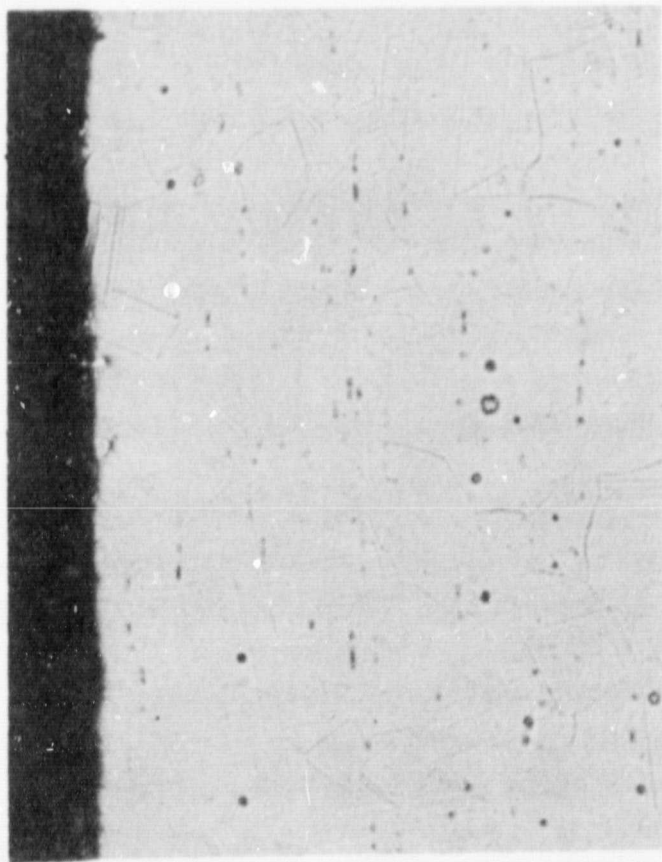
Surface attack with formation of a white, loosely adherent corrosion product was noted. This alloy was tested, primarily because of its chemical similarity to nickel. Resultant corrosion products indicated cobalt behaves considerably different than nickel in the sterilization environment with  $N_2O_4$ . Figure 12 shows a photomicrograph of this material's surface after testing.

Some minute pitting of the surface is in evidence.  
No intergranular corrosion occurred.

Fig. 12: Cobalt (L-605) after Exposure to  $N_2O_4$  for 600 Hours at  $275^{\circ}F$  (200x)

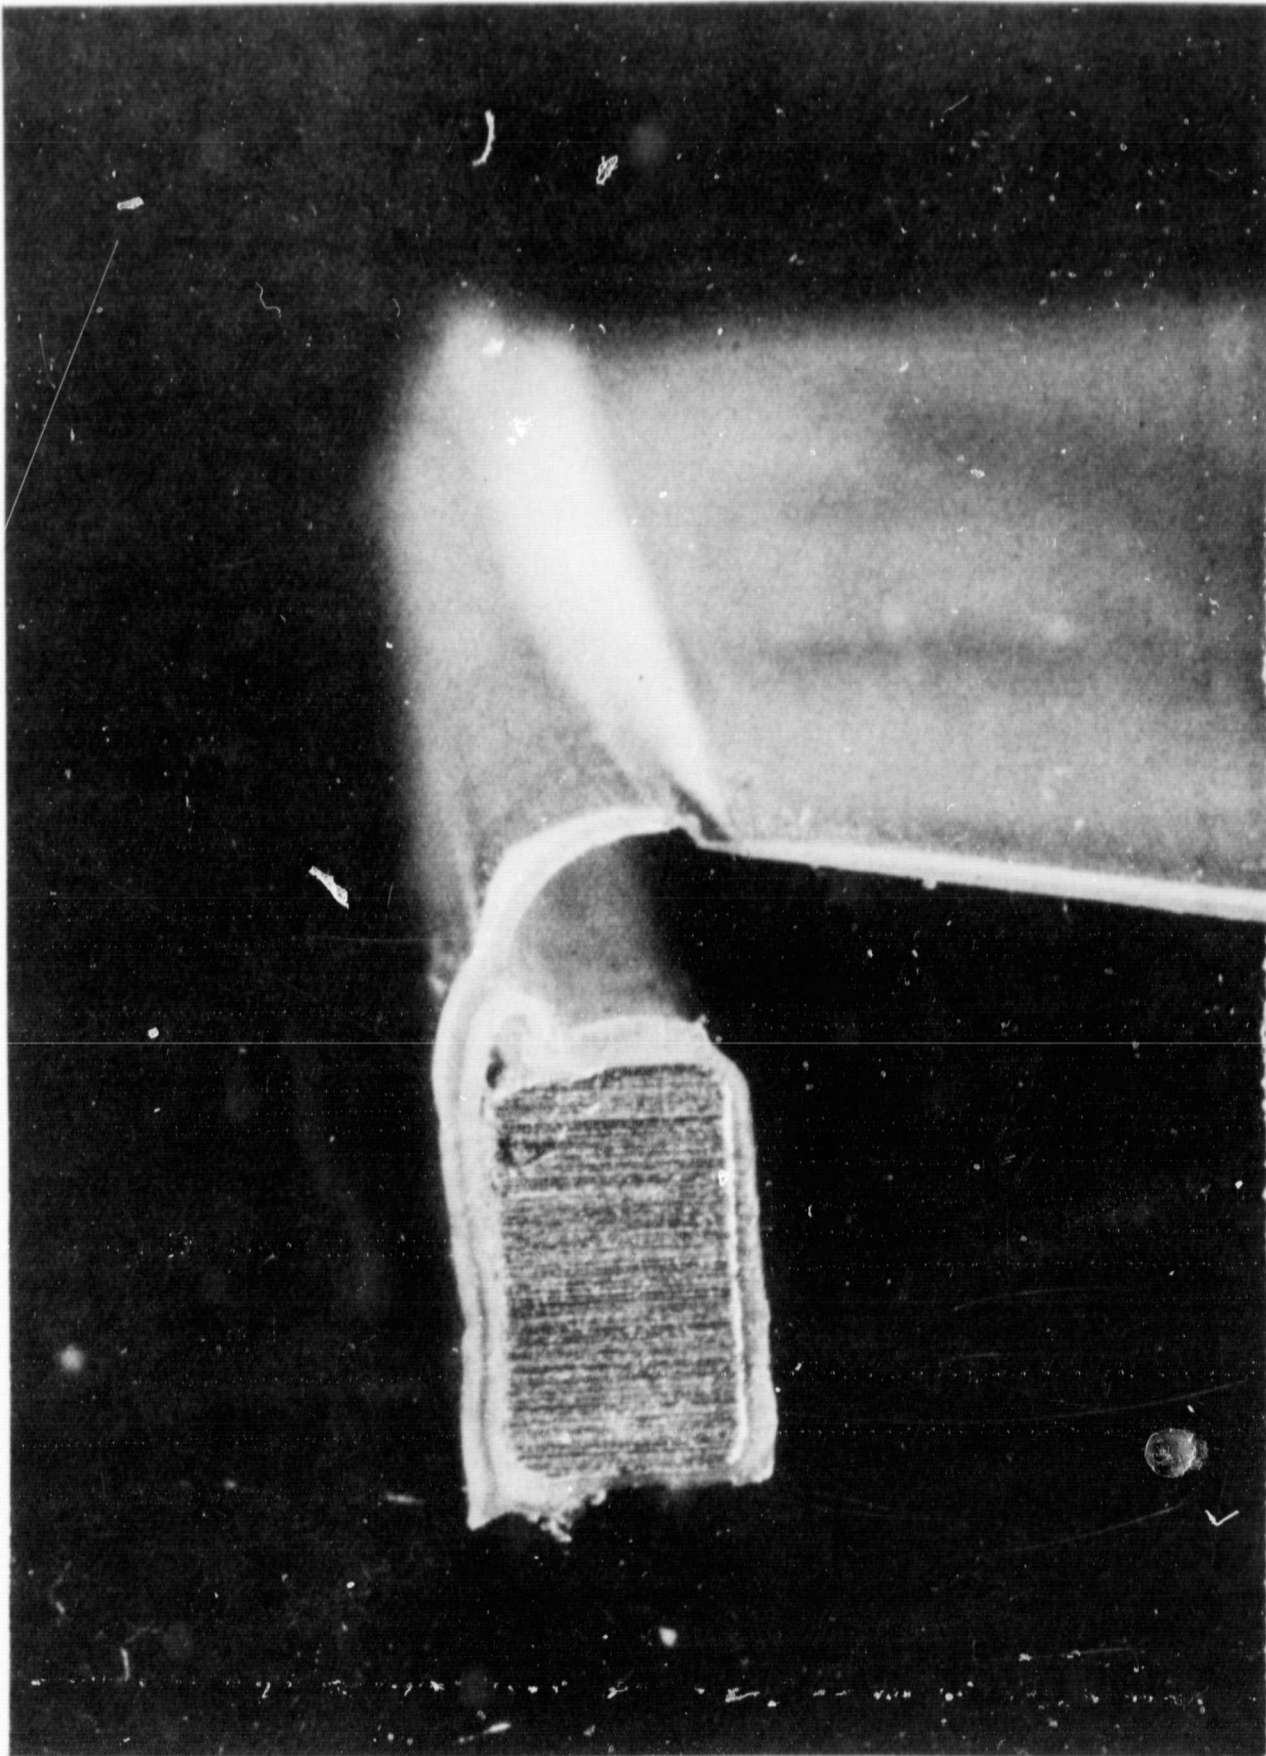
Fig. 13 Oxidizer Diaphragm S/N 101, Sectioned View

Diaphragm S/N 102 was removed from the tank hemisphere before a leak was developed. Both diaphragms exhibit similar failures in that the normal membrane is in good condition clearly showing the laminate of FEP and TFE Teflon.

The failures of both diaphragms occurred in the same area, i.e., near the flange ring heat seal. In both instances, the failure occurred adjacent to the diaphragm rolled or formed flange. From the figures a heavier section of Teflon is noted where the Teflon is sprayed into the corner area of the mandrel.

The condition of the S/N 101 ring flange seal suggests a deterioration of the seal area. It is not known whether the cause is due to the excessive heat at the corners of the ring resulting from the induction heating or whether excessive clamping loads were used. In any event the final condition is impossible to inspect for without destroying the diaphragm, the condition of S/N 102 does not show the same flow of Teflon around the ring flange yet the same procedure for heat sealing the flange to the diaphragm membrane was employed. The vendor implemented the pre-formed rolled flange on this diaphragm because an earlier configuration that was sprayed on a straight section caused ripples when the skirt was rolled over the flange ring.

The corrective action implemented was to size the diaphragms for a line-to-line contact at the normal inflation pressure thereby reducing the expected stress levels. This will reduce the loads imposed on the diaphragm at the natural stress concentration point at the flange ring seal. The diaphragms have been resized so that no more than 1% stretch is imposed from the relaxed condition of the membrane.
